CONCRETE REPAIR

Repair Project of the Year

*The Bahá'í
House of Worship*

The Baha'i House of Worship Restoration

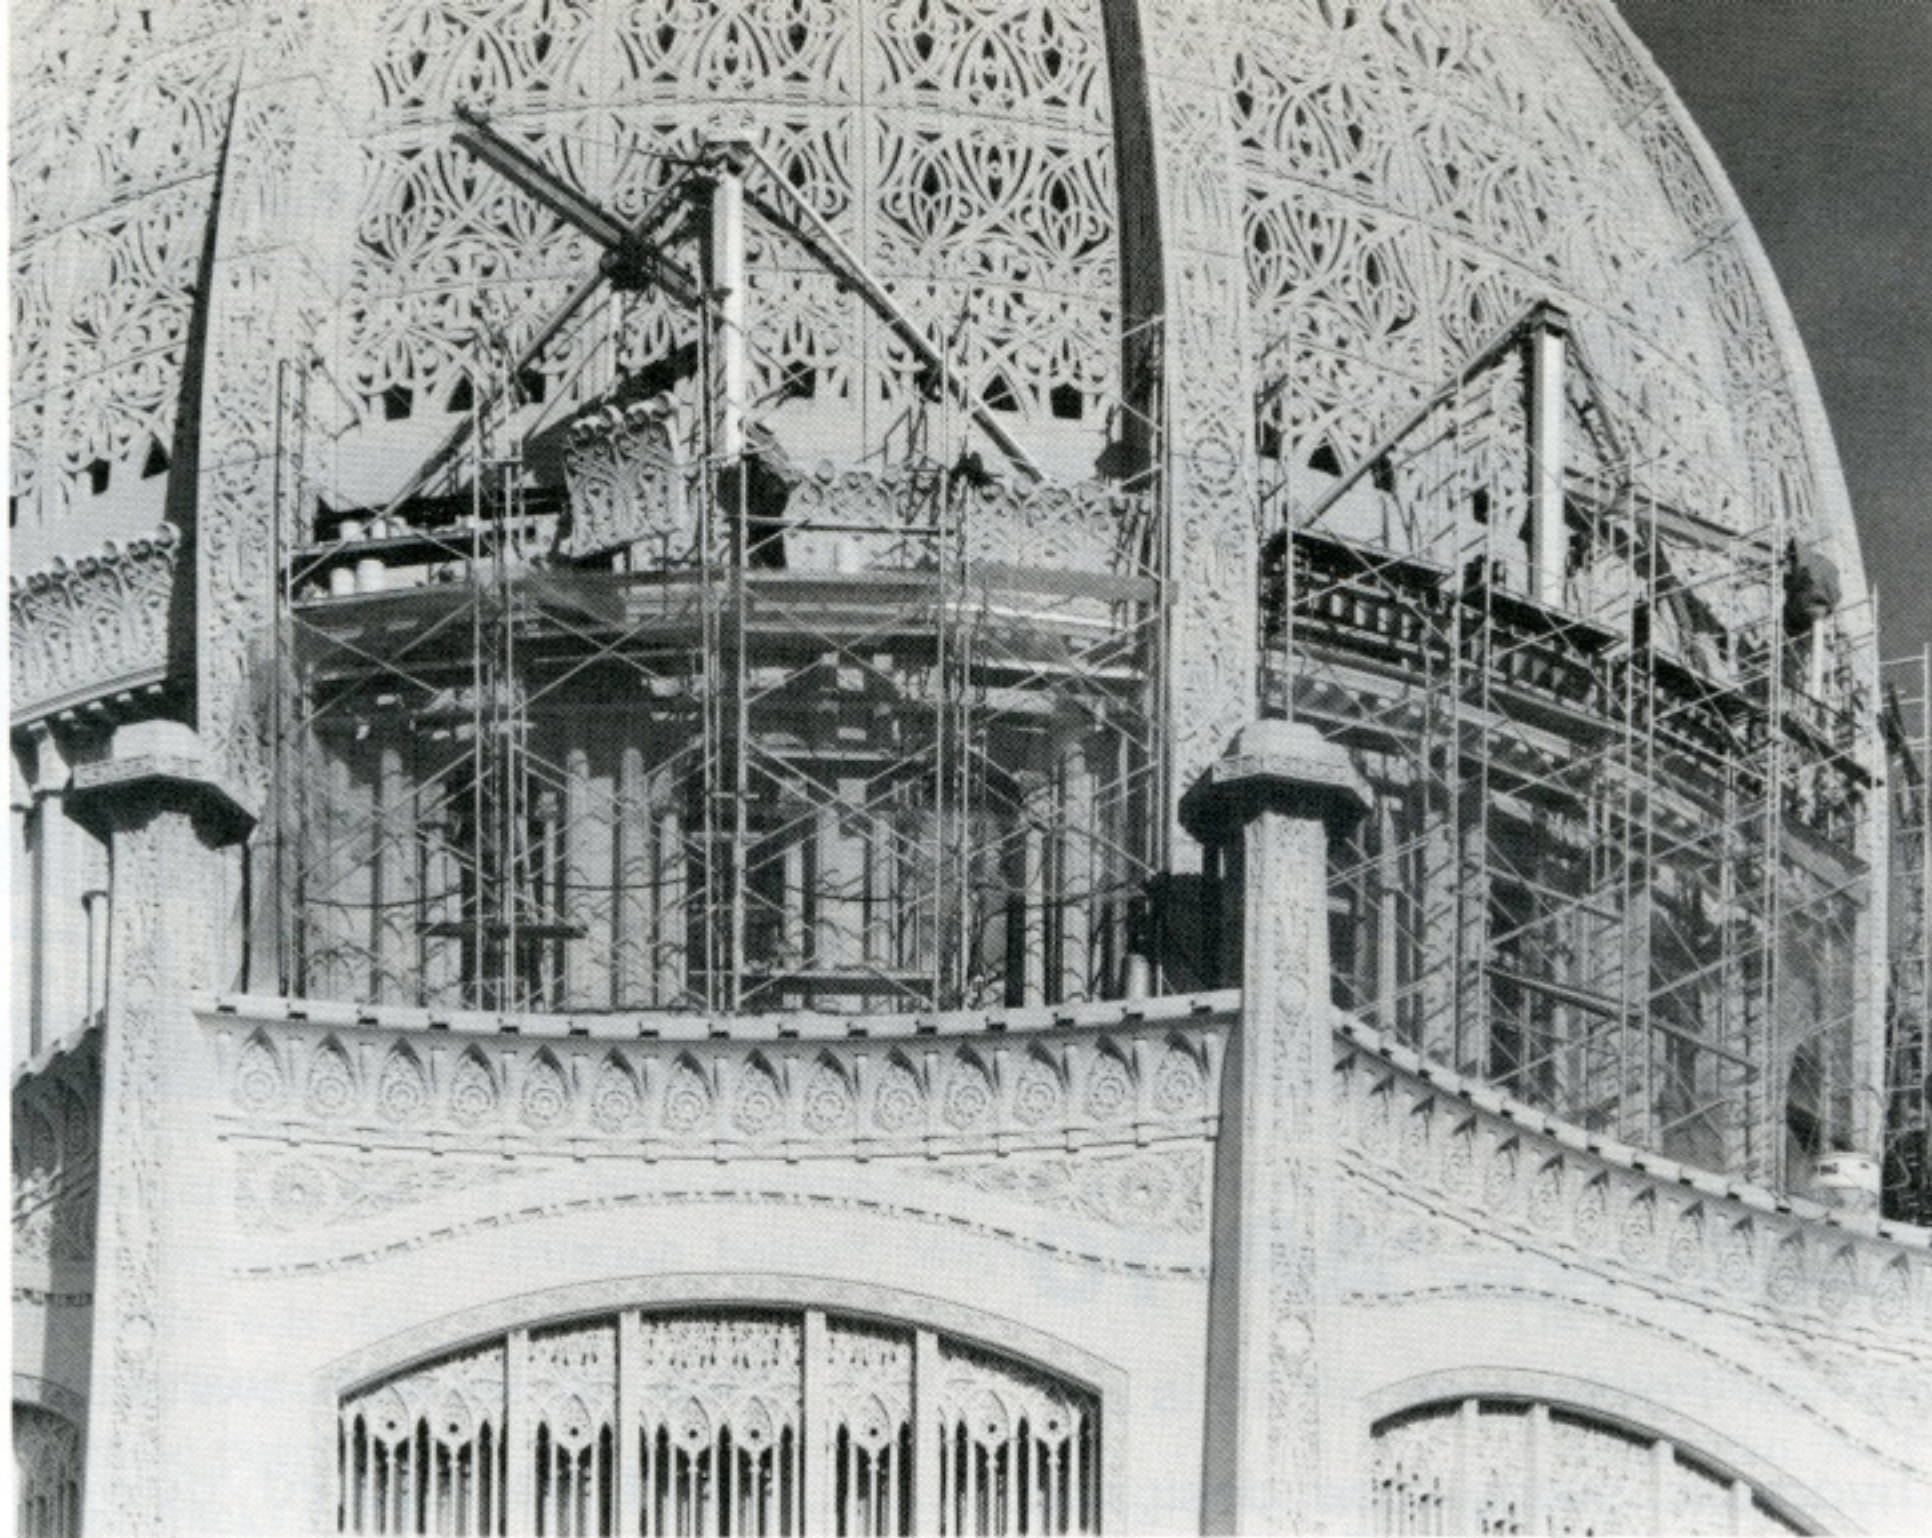
Special hoisting and access systems were designed for the repair of the Baha'i House of Worship located in Wilmette, Illinois. Photo by Scott Corrie.

Custom Hoists Designed - Customized hoisting and access systems were designed for the building. A large stationary trolley hoist was used to lift materials from the service driveway on the ground up to the first story roof. Materials were moved around on the roof level using carts.

Small aluminum cranes mounted on the dome lifted materials and equipment up to the work area. The cranes and scaffolding on the upper roof were moved from section to section as work progressed. All of the hoisting systems were anchored onto the build-

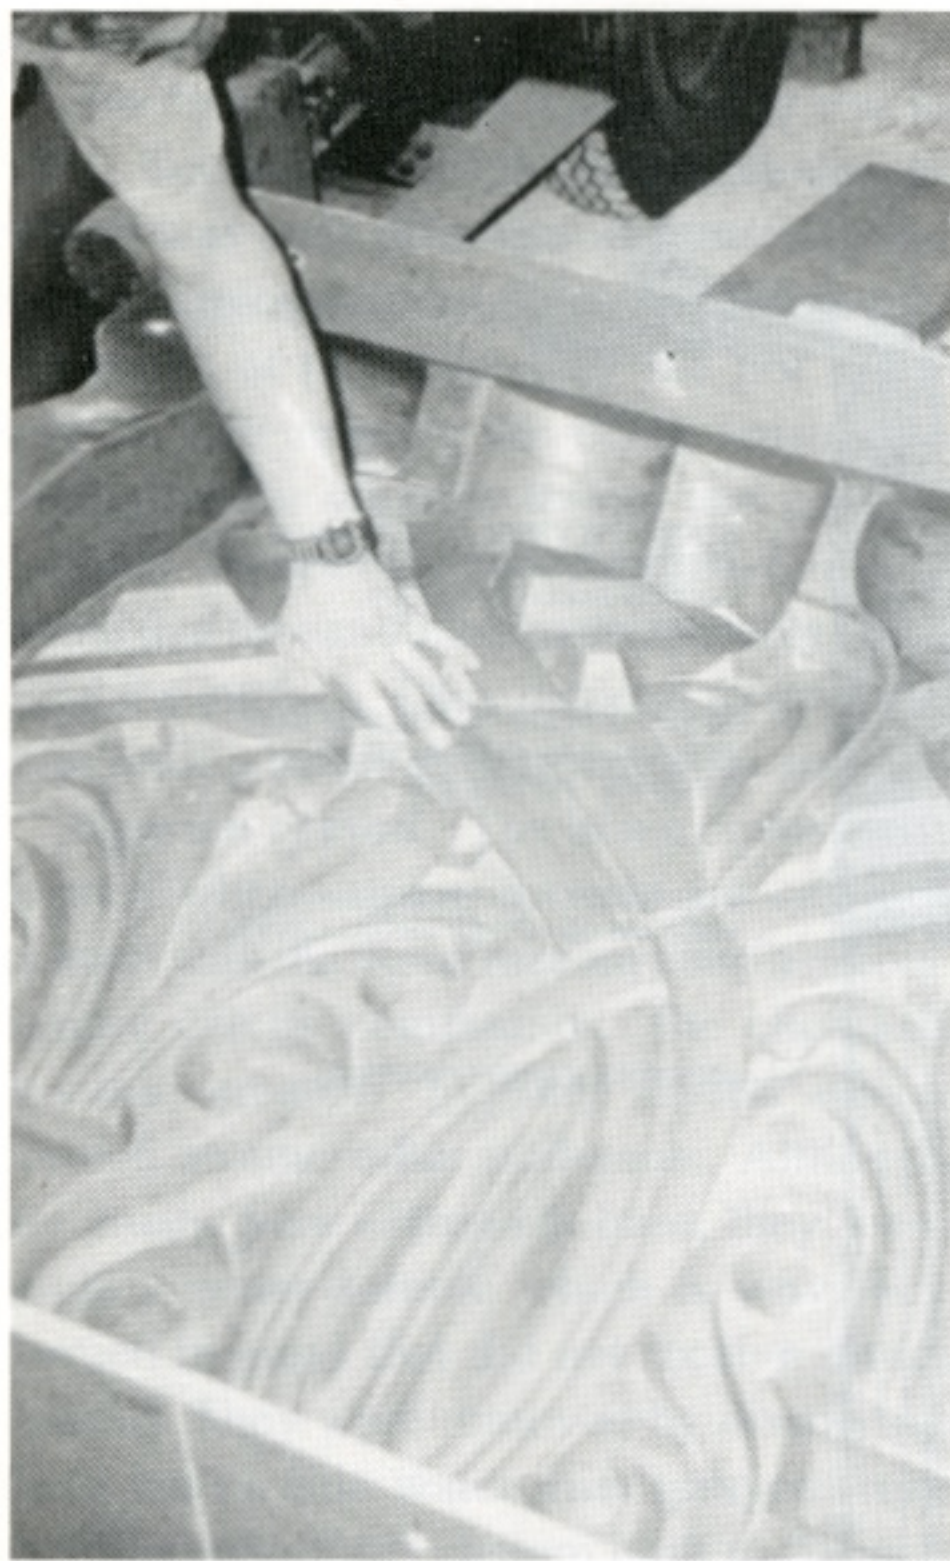
(Left) Intricate multi-piece fiberglass and rubber molds provided for accurate and efficient repair of the highly sculpted ornamental concrete components. (Right) Diagram by Wiss, Janney, Elstner Associates, Inc.

The ornamental face of the crown was replaced with precast architectural panels of white quartz concrete. The panels were produced in the temple's shop using intricate fiberglass molds coated with a retarder to allow easy exposure of the quartz material. After three weeks of curing, the panels were attached to the repaired structural concrete using adjustable stainless steel angles and expansion anchors. A new copper gutter and new drains were installed at the base of the dome. Cracks and spalls in the clere-story were repaired using similar techniques with the white concrete mix.

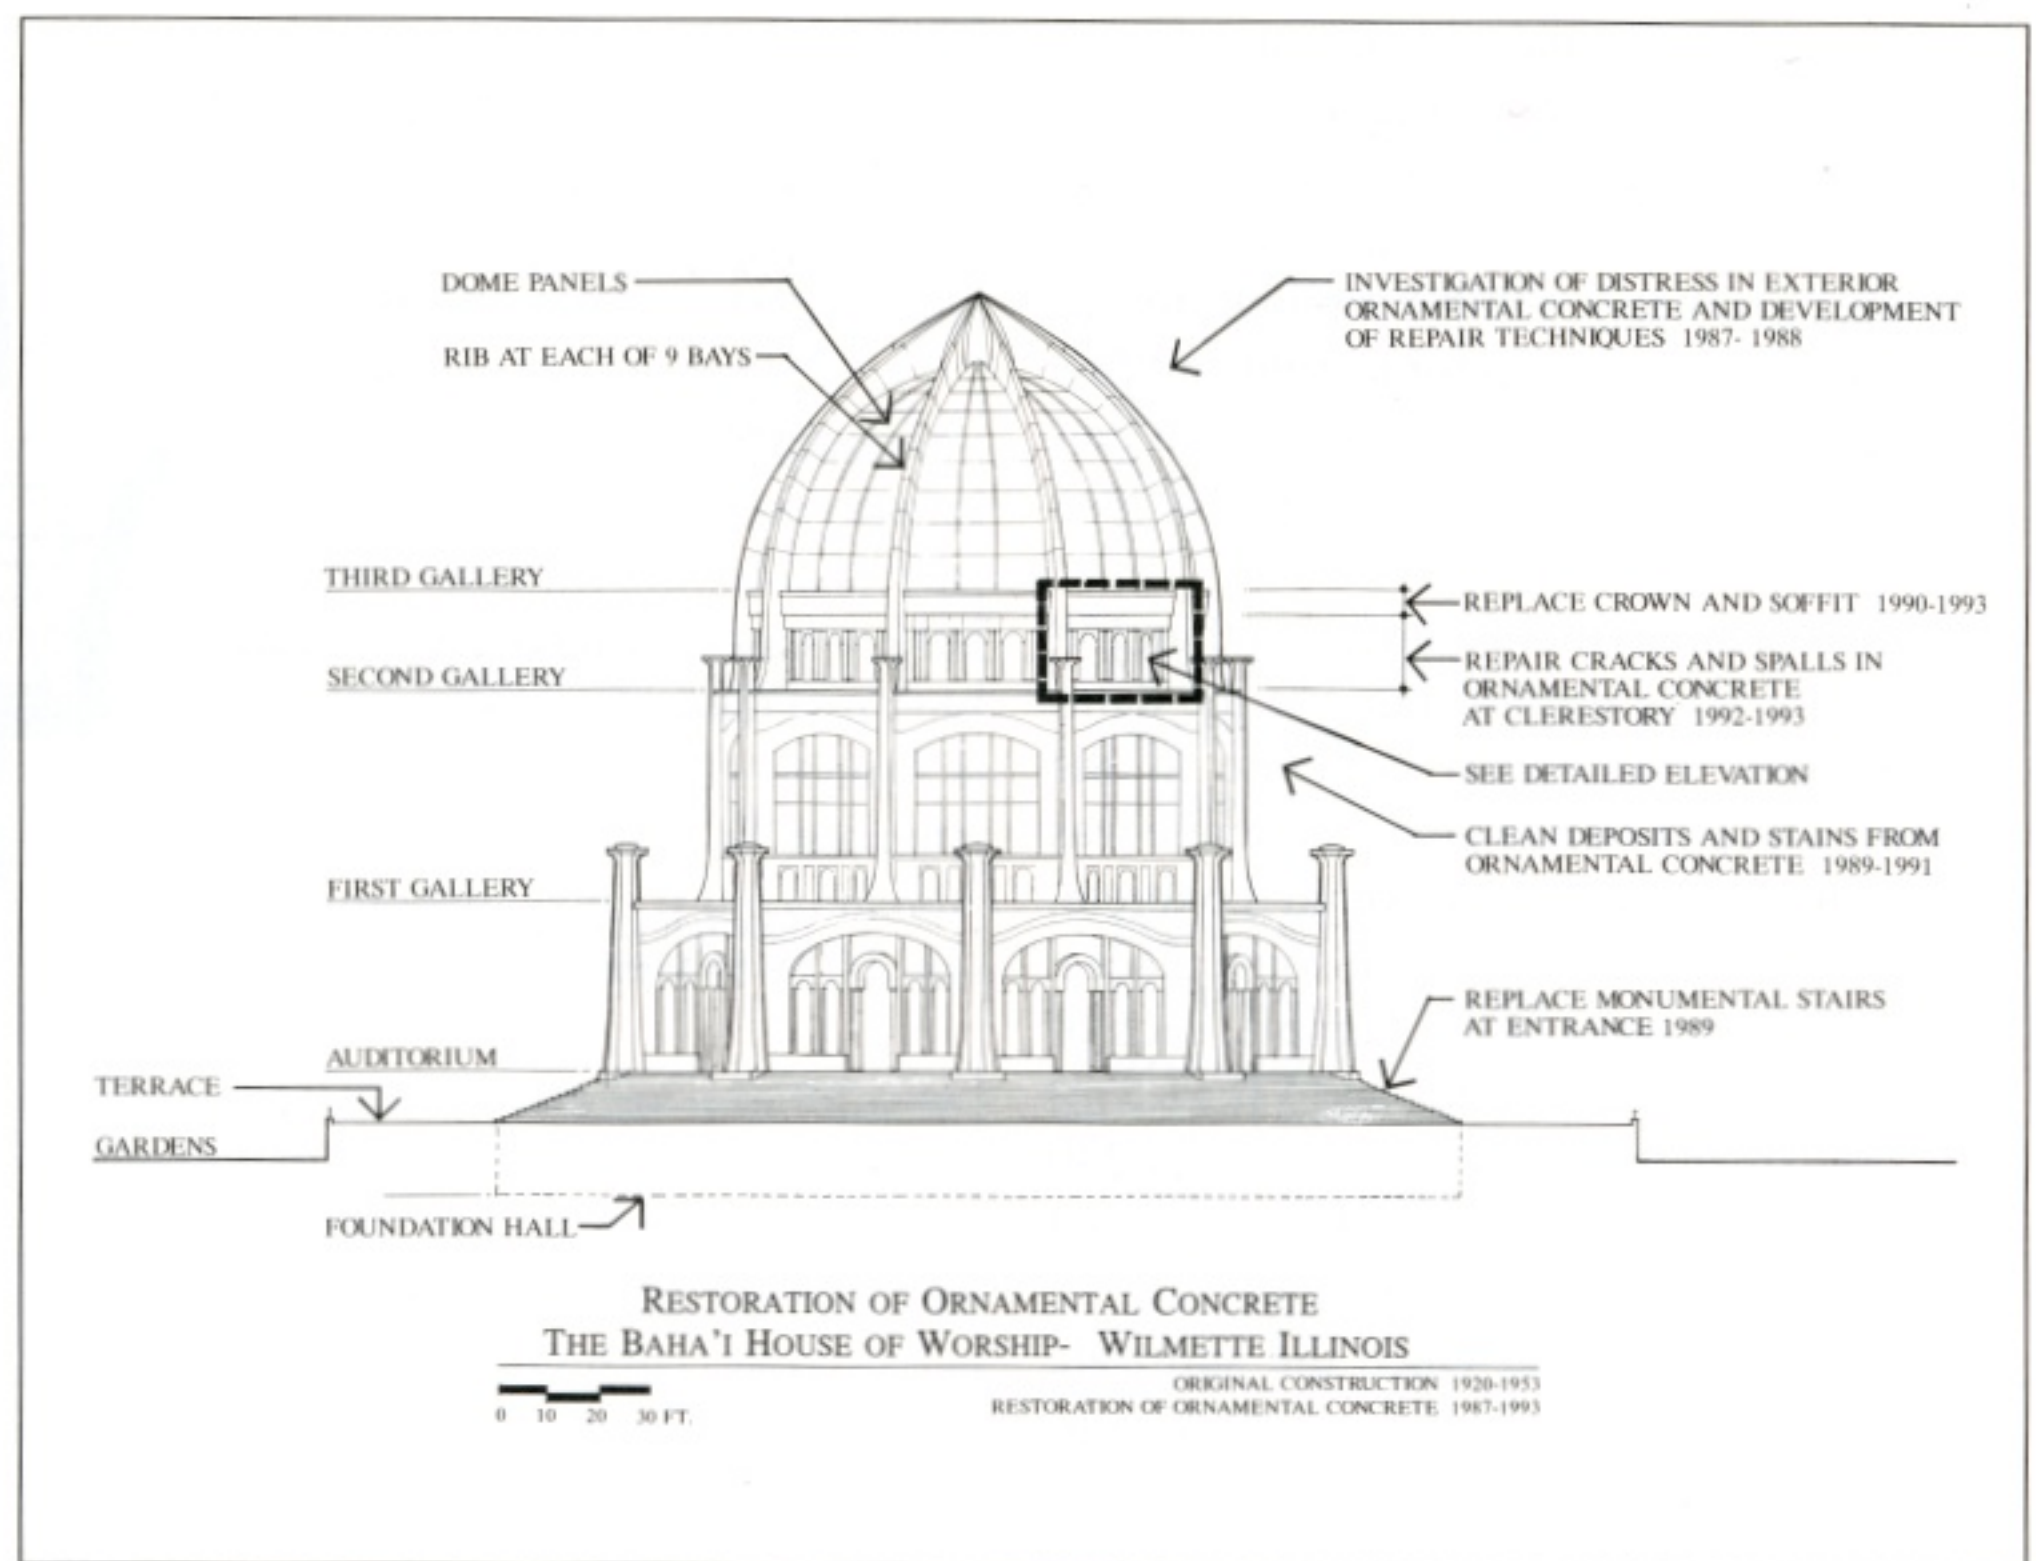
Most of the ornamental concrete in the area along the cornice, soffit and dentils, appeared to be in good condition, but some places showed deterioration. The investigation revealed that damage to the concrete of the crown was caused by cyclic freezing of critically saturated concrete. In addition,

steel anchors of the ornamental concrete to the structure were fractured as a result of expansion due to water freezing.

A gap of up to one inch (25 mm) was found where the white ornamental concrete had originally been in contact with the underlying structural concrete. Petrographic analysis of the samples showed that the structural concrete was damaged as much as 30 in. (962 mm) below the surface, even where the white ornamental concrete appeared sound. The damage did not affect the overall strength of the building's structure, but it weakened the support for the ornamental concrete.

In the nine sides of the Temple, each of which is 31 ft. (9.5 m) wide and 5 ft. (1.5 m) tall, craftsmen drilled, and set in epoxy 240 new steel anchors 3 ft. long. Epoxy coated steel reinforcing rods were carefully fit behind curved forms. Once the substrate was properly prepared, the structural concrete material was then placed into the forms. After the forms were removed, the concrete cured for three weeks under a plastic wrap. (See diagram at right.)

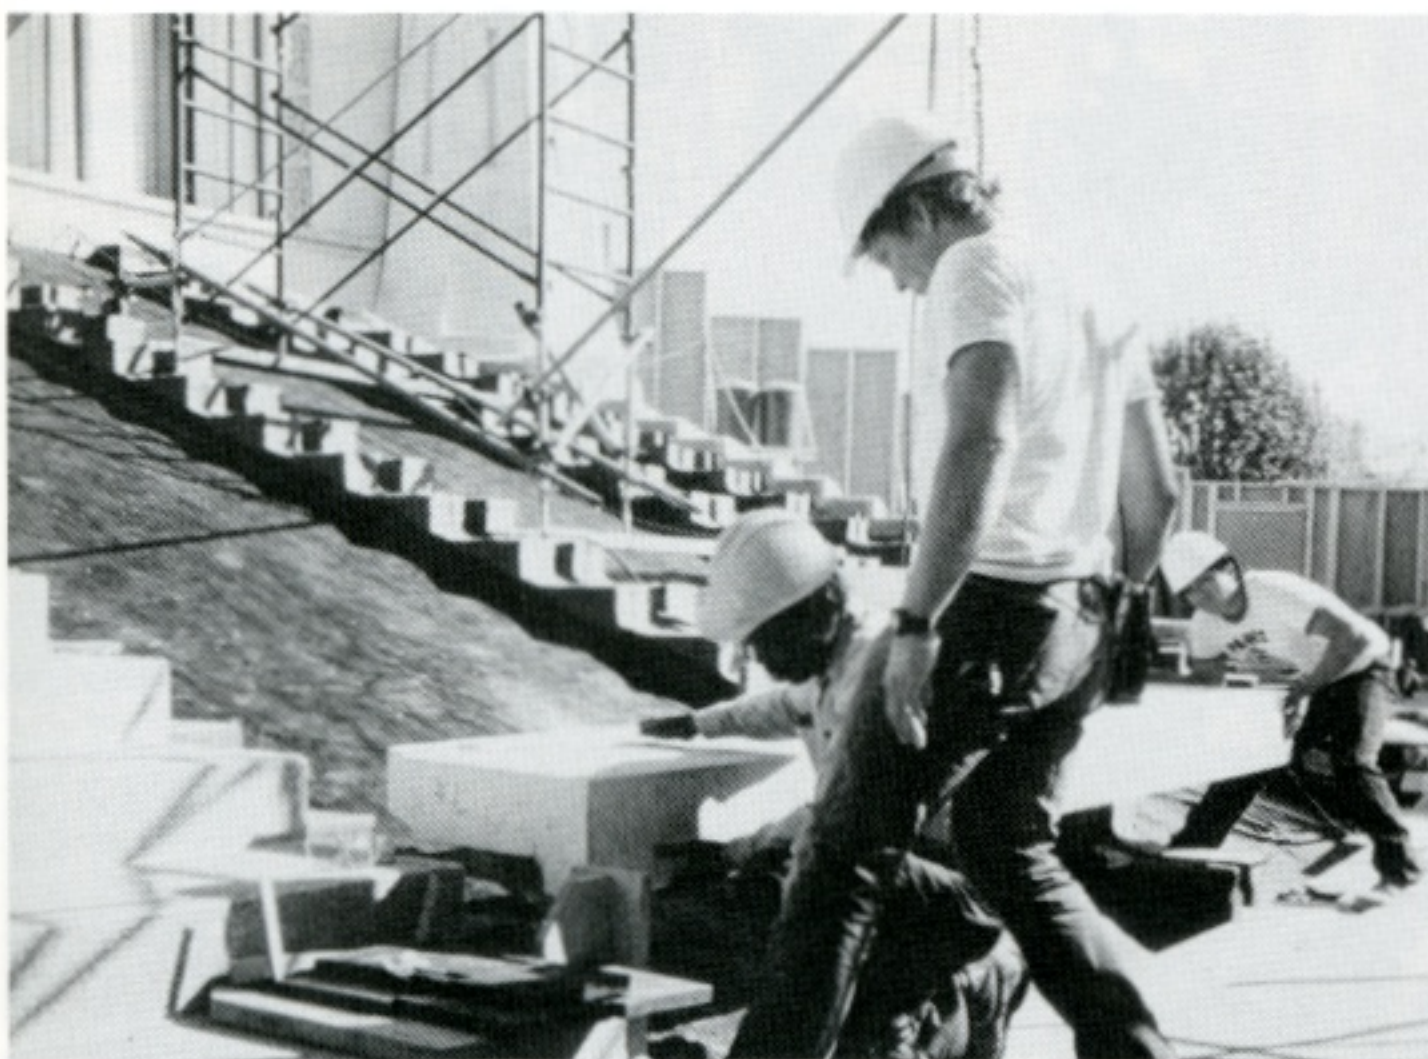
Workmen replace pre-cast stairs at entrance to the temple. A waterproofing membrane on the sloping concrete deck below the stairs protects occupied space inside the building.

The first stage in the repair program addressed the monumental stairs at the Temple's entrance. The existing precast stairs and the cast-in-place upper landing were removed. The water-resistant membrane beneath the stairs was replaced and a hot water snow-melting system added to avoid the future need for damaging chemicals. New precast architectural concrete stairs and cast-in-place upper landing duplicated the original appearance.

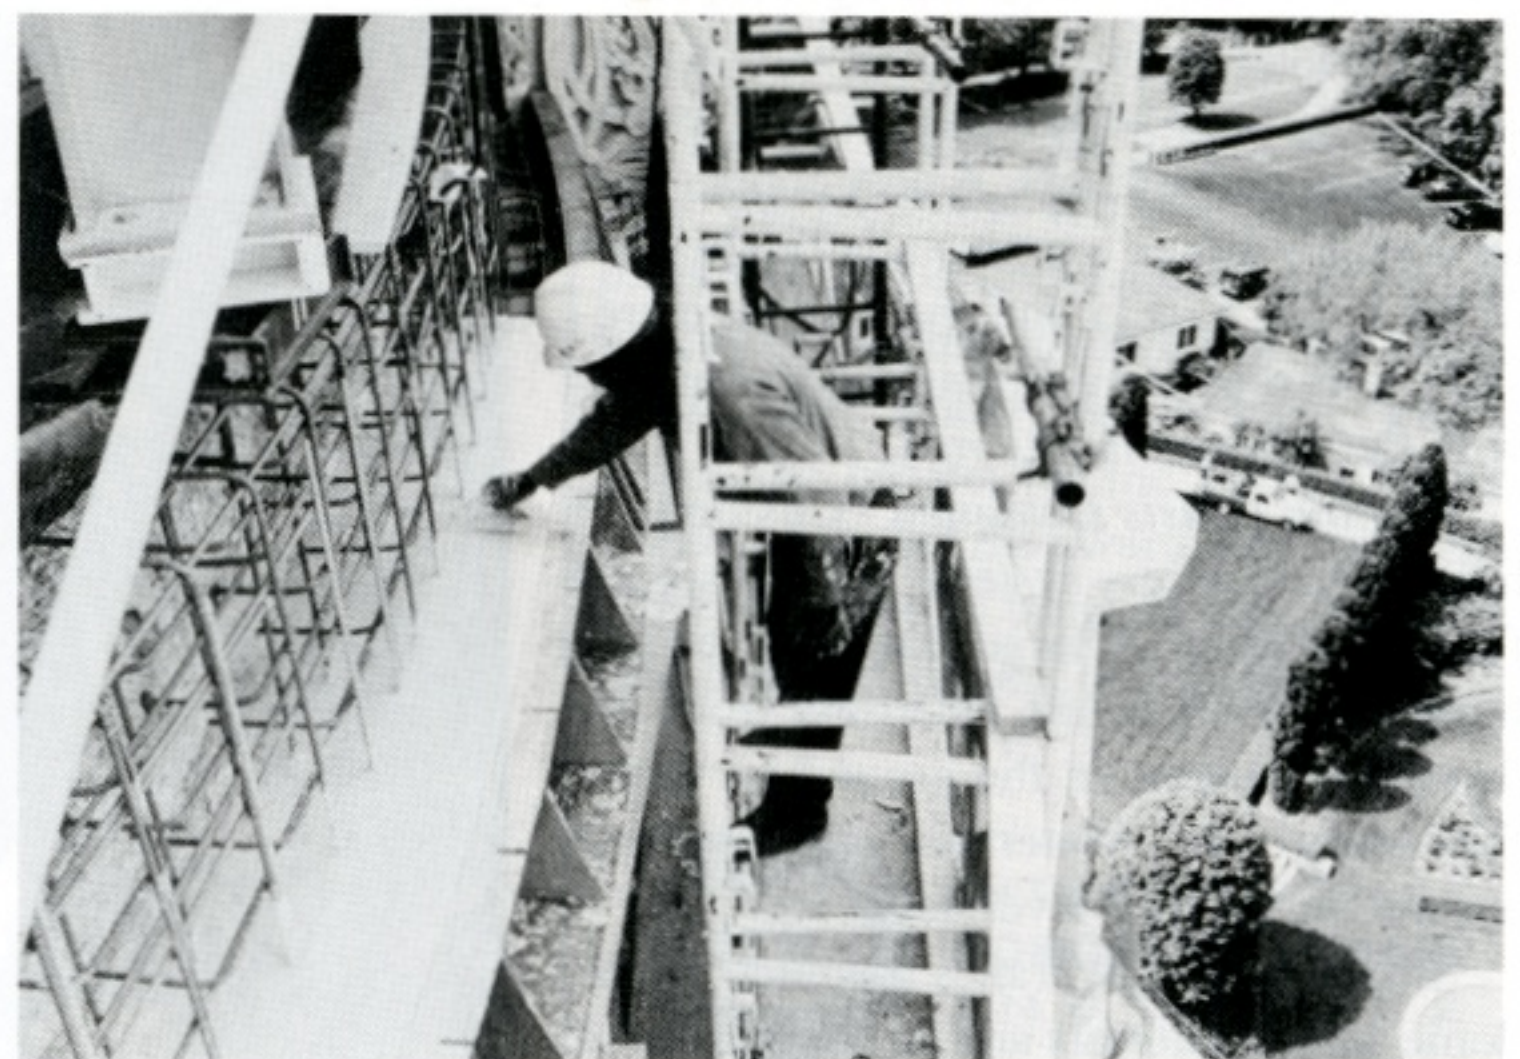
Technician finishes cast-in-place white quartz soffit and dentil section. A later placement of grey structural concrete will encase the epoxy coated reinforcing steel that ties the soffit and structural repair into the remaining original concrete.

The ornamental concrete of the soffit and dentil section was cast in place using white quartz concrete placed into rubber molds. A retarder on the inside surface of the molds facilitated exposure of the quartz aggregate with wire brushes when the molds were removed the next day.

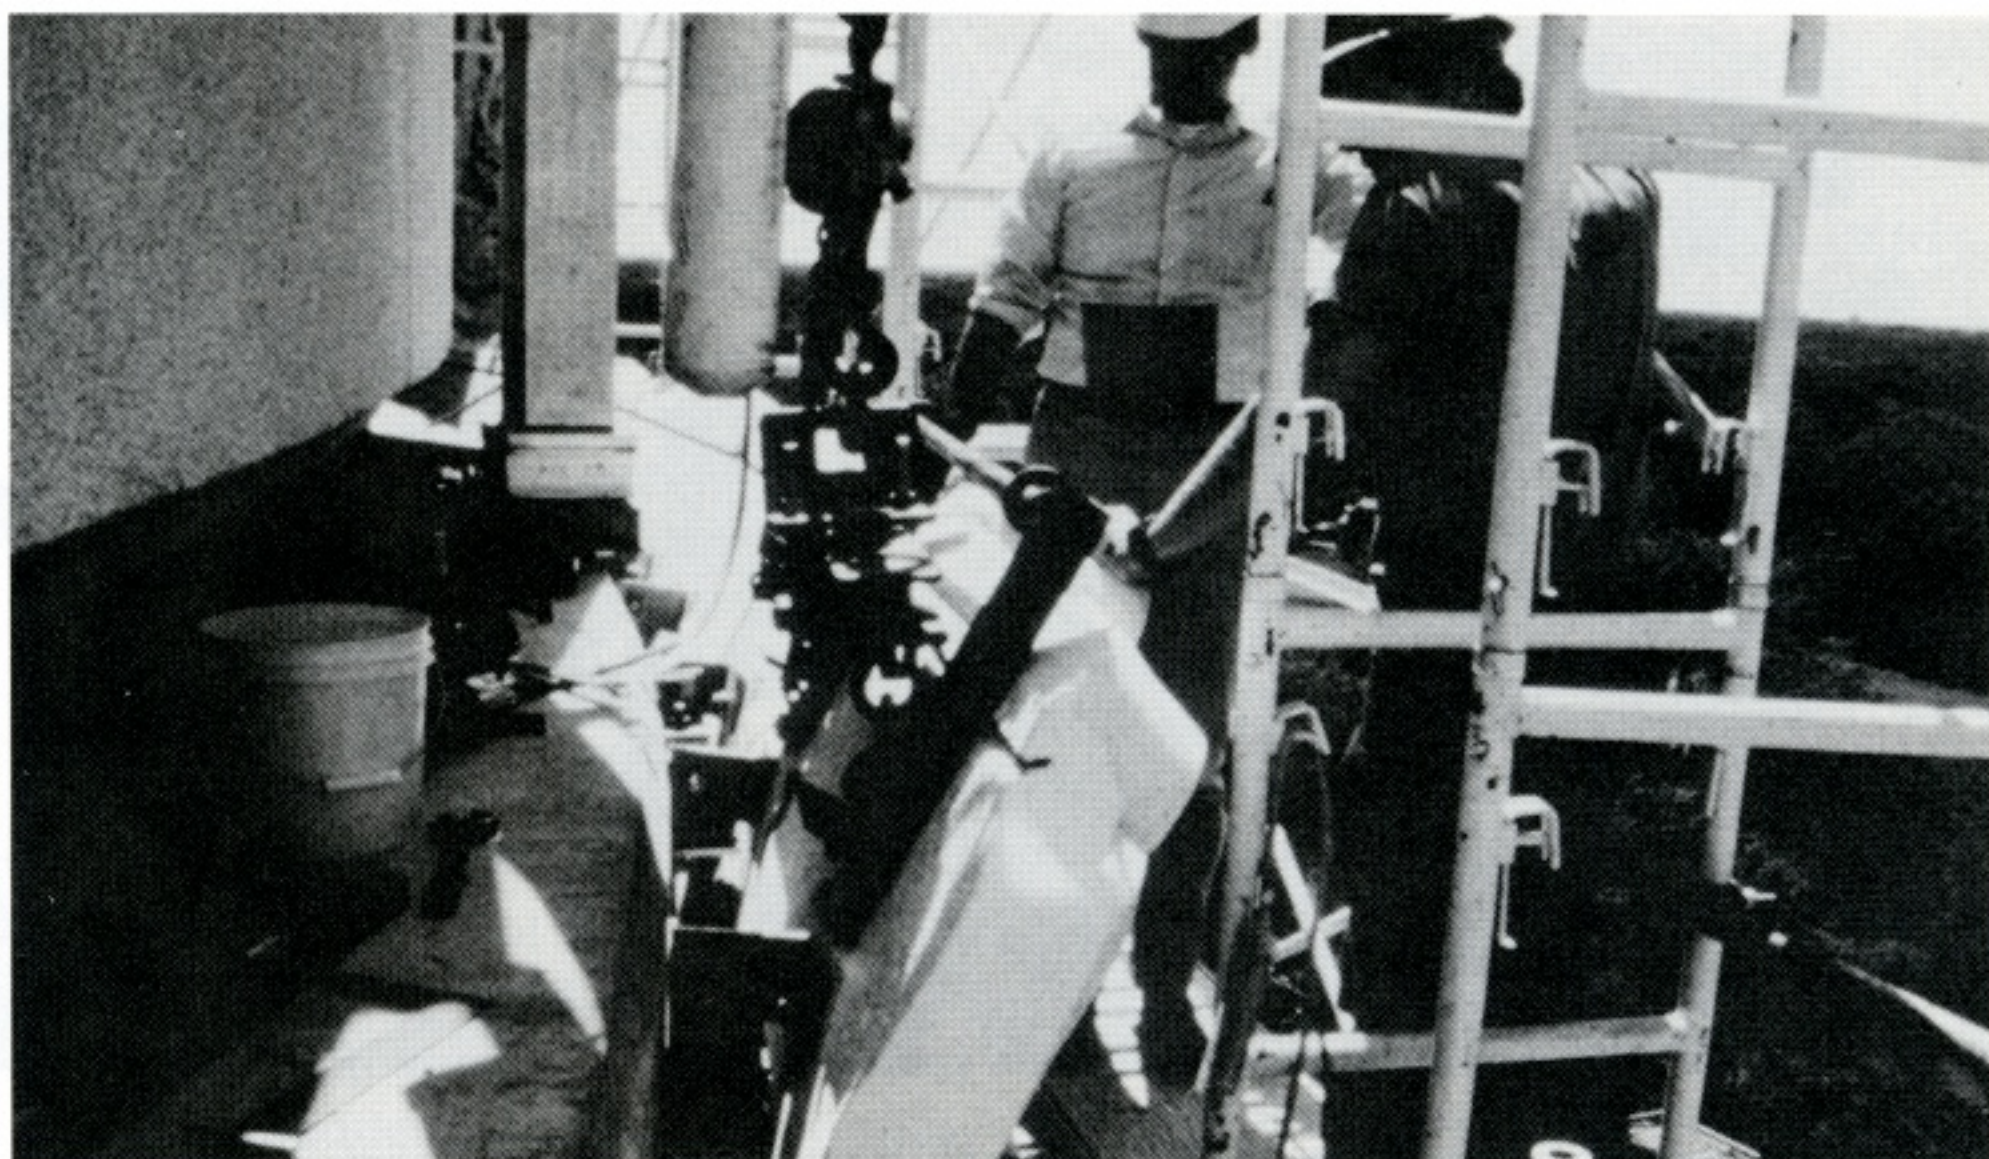
New precast, white quartz ornamental concrete panels are attached with stainless steel adjustable fittings to maintain uniform 3/8 in. (10 mm) gaps across curving joints. Open cavity behind panels provides a free draining weep system. Photo by Robert F. Armbruster.
