The Fair Face of Concrete
*Conservation and Repair
of Exposed Concrete*

Restoring brilliant ornamentation

The Bahá'í House of Worship (Louis Bourgeois, 1920-53)

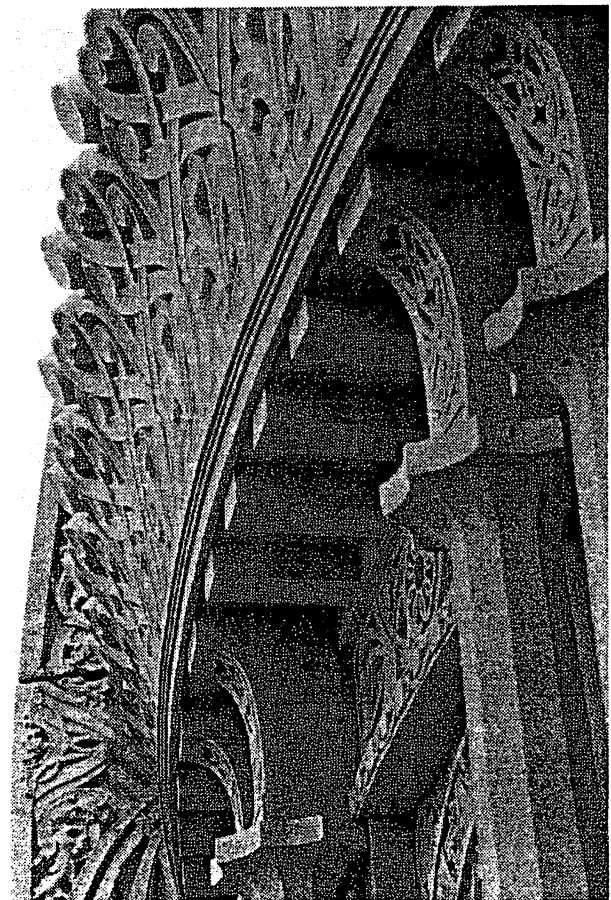
Close-up after restoration. Photo: R. Armbruster, 1993.
